Need for better accessibility on Karl Johans gate (street) Project “Levende Oslo”

International Conference on Universal Design (UD 2014)
Ingvild Kvalheim and Yngvar Hegrenes, *The Agency for Real Estate and Urban Renewal, Oslo Municipality, Secretariat Levende Oslo*

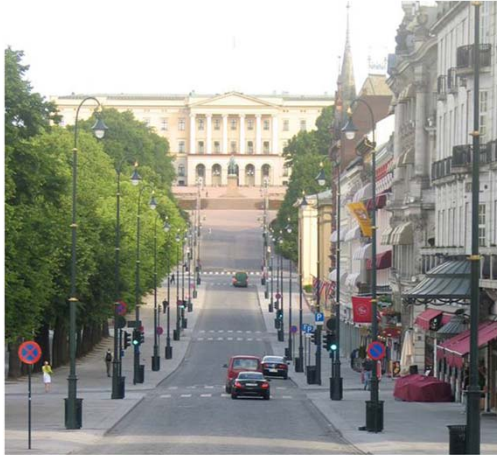
Karl Johans gate

Scope:

- The entrances to 75 public-oriented businesses
- Conservation Value in 42 buildings

Phases:

1. Registration of accessibility and conservation values
2. Pilot project: feasibility study for new universal designed master plan for access

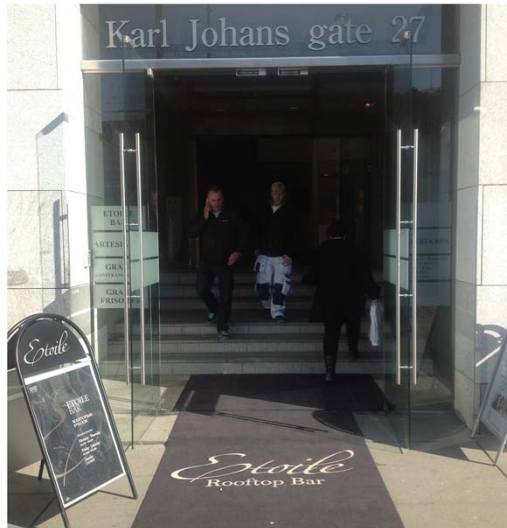
Identified deficiencies:

1. Physical characteristics
2. Layout

For some of the businesses there are very few faults to be corrected to achieve universal design, but several have deficiencies in access routes and entrances which makes access difficult for some.

Identified deficiencies in universal design can be divided into two main groups:

- 1) Faults related to the physical characteristics of the street / sidewalk and structural adaptations such as stairs, steps and thresholds at the entrance.
- 2) Deficiencies related to layout, fixture, signs etc., as well as elevators, toilets, changing rooms and internal stairs.

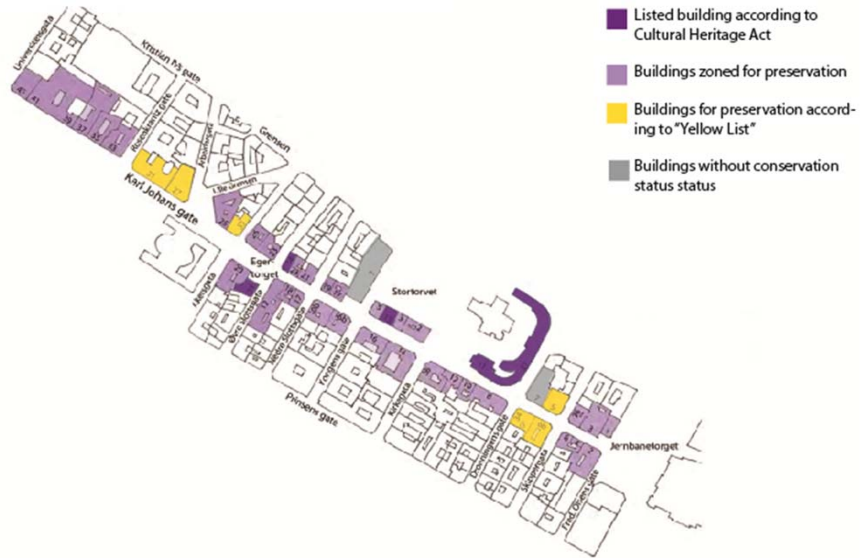
Map section with an overview of the building's heritage status:

In addition to register deficiencies we also had to take into account the conservation status, and this image shows the building's status.

Most of the buildings are zoned for preservation, only two buildings are without conservation status (grey).

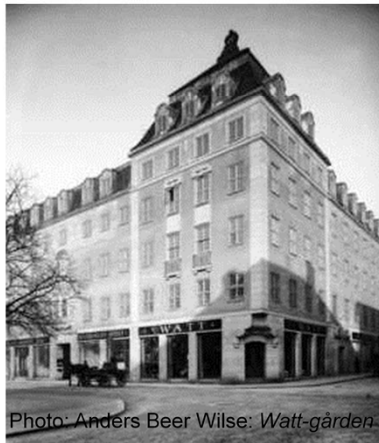
Photo: Anders Beer Wilse: *Watt-gården*

1858	Built
1916	Entryway included in the shop, the shop gets direct access from the street
1931	New wall at ground floor: glass and iron
1958	New entrance in the basement for a restaurant
1962	New shop facade
1979	Building zoned for preservation as a part of a historic area
1984	New entrance
1985	New shop facade
1986	New shop facade
1987	Baldachin above the shop entrance
2013	Total renovation of the shop
2014	Legality: All availability requirements must be met according to Tek 10, and a new planning application must be submitted.

This building is zoned for preservation as a part of a historic area, but changes and renovation are not always notified; and after the years changes that have not been *approved*, but which requires approval, pops up. (In addition to the history at this slide) Minor changes over the years becomes huge changes summarized.

- Both entrances contains a staircase
- The two floors are connected with stairs
- And there are a lot of other solutions which makes accessibility for all impossible.

It is now created an extrajudicial case on the property. (All requirements must be met according to The Technical Principles, and a new construction application must be submitted.)

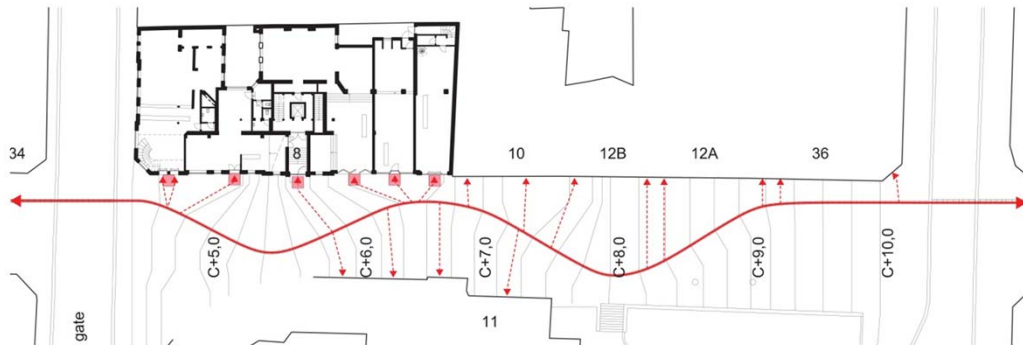
Pilot project – street adjustment

Then modelling the street as several ramps to *every* entrance, with a path in the middle of the road with correct gradient according to the Norwegian Standard.

- with half an eye you can observe that this is *not* universal designed
- Making the street into a space between the blocks and not a street with an important direction
- Making the street dangerous to walk, just like an undulating landscape
- Difficult to enter the entrances perpendicular to the facade
- Difficult to walk along the facade
- Difficult to spot the entrances; not very logical guiding in the street
- If you think of **motion - vision - hearing - orientation - sensitivity** – it work for the groups sensitivity and hearing

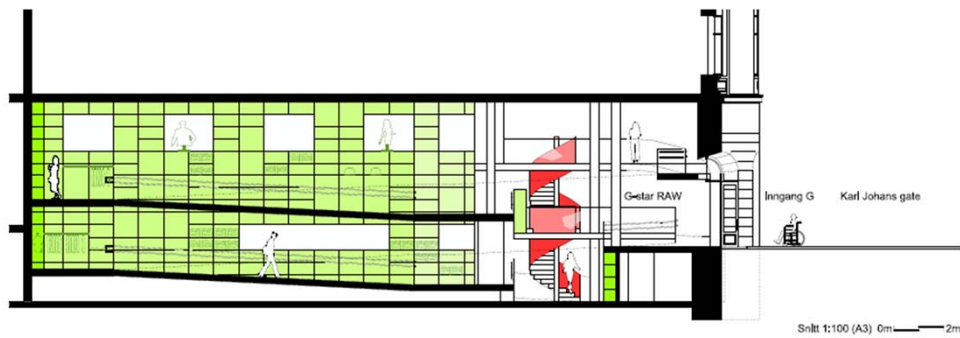
Pilot project – Interior adjustment

Then making the *entire interior* into a ramp with shelves and activities along the ramp; some comments from the experts:

- Not universally designed except for the correct gradient in the slope
- Not possible in a building with conservation value
- Too expensive for a small business
- It is important to give the visitors/customers a good experience, this solution is not suited for all
- (and the layout/graphics are not universally designed)

None of the *these* solutions are neither innovative nor universally designed. We are still in progress to find our pilot project.
