# A Continuous Guidance Route in the City of Borlänge

## A study of Four People Who Are Blind and Their Walks Along the Route

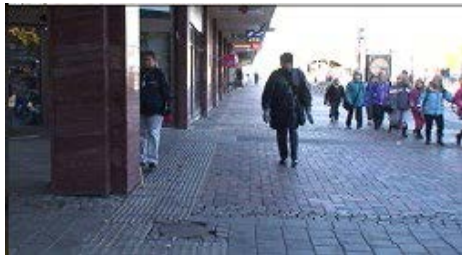
Photo 1.

On the basis of this study we can establish that **wide guidance surfaces** (70 cm) are experienced as better than narrow ones (42 cm). Another important result is that wide artificial guidance surfaces are not experienced as good under any conditions. In certain situations, a wide guidance surface is thus no asset if the surrounding material is, for example, small paving stones or coarse gravel. There must also be a **sufficiently large smooth surface, ca 60 cm wide, on either side of the artificial guidance surface**. In the area tested, the guidance surface was directly connected to columns in several places, which caused some of the participants to collide with them and consequently lose their orientation. The bus stop in Stationsgatan is an example of an interesting solution, where the guidance route with an artificial guidance surface and warning surfaces leads up to, and through, the windbreak, thus enabling the participants in this study to find the bus stop and the windbreak without difficulty, Photo 1 and 2.

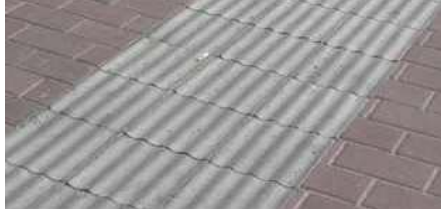
As for the **detail design of sinus slabs** as guidance surfaces, different varieties are produced in Sweden today. One variety with a sinus curve ending in a top at the edge of the slab is installed with the top of the sinus curve on a level with the surrounding surface material, Photo 3. Another variety, where the sinus curve slopes into a valley, is installed so that the valley of the sinus curve is on a level with the surrounding surface material, which means that the top of the sinus structure is 5 mm above the surrounding surface material, Photo 4.

This study demonstrated even more clearly than previous ones that the participants found it easier to identify slabs where the **sinus curve is higher than the surrounding material** than those where the top of the sinus curve is on a level with the surrounding surface material [15]. The florist in Stationsgatan and the information sign for Missionskyrkan in Borganäsvägen are examples of places with slabs where the top of the sinus curve is higher than the surrounding material. The restaurant in Borganäsvägen and the walking path up to the windbreak at the bus stop in Jussi Björklings väg may serve as examples of places with slabs where the top of the sinus curve is on a level with the surrounding material.

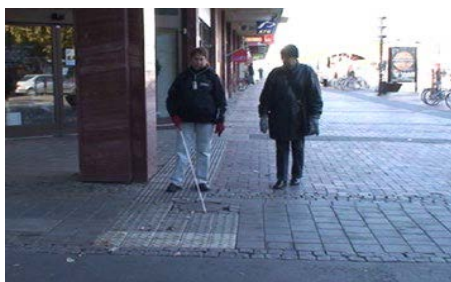
One fundamental detail in creating safe guidance routes is the design of the **transition from a guidance surface to a warning surface**. Previous studies have identified difficulties in detecting warning surfaces in the form of cupola slabs following artificial guidance surfaces consisting of sinus slabs or ribbed slabs [16]. These findings are also confirmed by the present study, where the depth of the warning surface was up to 140 cm in places, i.e. more than the recommended minimum depth of 100 cm. Our study also shows that the detail design of the cupolas has an impact on detection. Cut cupolas were easier to identify, since the cane tended to get stuck between the cupolas. Disturbing ground installations in the entire, or parts of, the guidance surface, such as manhole covers, constitute another detail that makes both detection and orientation more difficult, Photo 5. In this study the continuous walk of the participants was disturbed by manhole covers, e.g. in the vicinity of the florist in Stationsgatan, Photo 6.

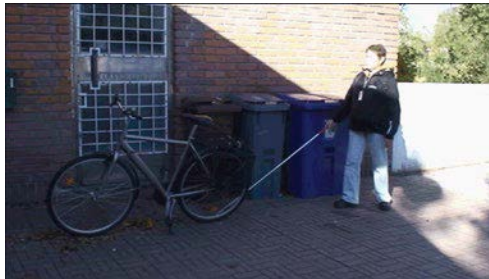
Photo 7.

This study clearly highlights the problems caused by obstacles along the guidance route, not least along planned natural, or even artificial, guidance surfaces. When the tests were conducted, flower boxes just beside the artificial guidance surface along Stationsgatan distracted some of the participants so that they lost contact with the guidance surface. The same type of problem was caused by people who had stopped to have a chat on the pavement and by clothes racks along Borganäsvägen, both in the

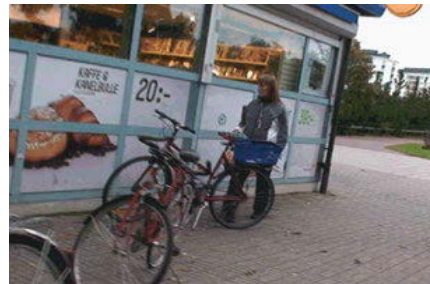
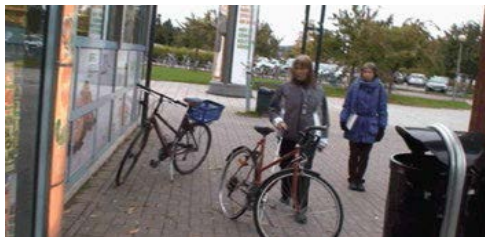
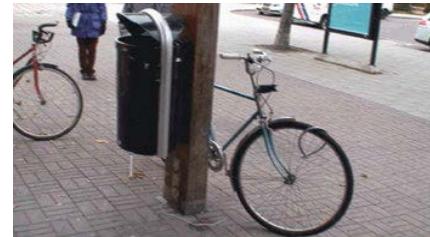
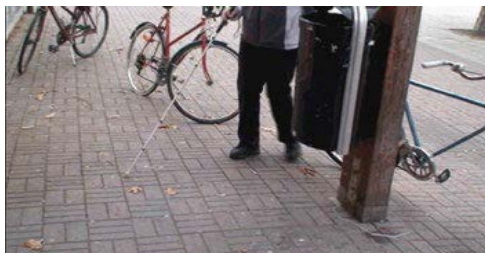
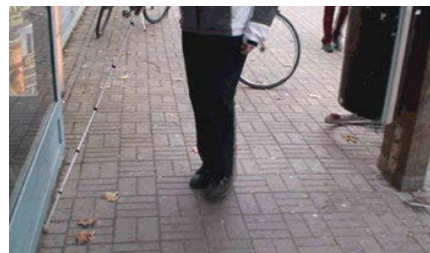
pedestrian street and along pavements in the area. On several occasions, participants walked straight into people and clothes racks along the walking path. Garbage cans and newspaper stands outside houses and buildings also posed a problem for participants while orienting themselves along walls with the white cane, Photo 7. One big problem often quoted by people with impaired vision is bicycles that have been inappropriately placed in the walking paths. On one occasion a participant walked into three bicycles parked outside Resecentrum, tipping one of them over. Fortunately the participant was not injured, Photo 8 to 12.

It is therefore important to design clearly **demarcated bicycle stands** in the immediate vicinity of the entrances of public premises and other buildings to prevent people from parking their bicycles just anywhere, and often where people with impaired vision are supposed to orient themselves along natural or artificial guidance surfaces. In planning, there must also be **coordination between outdoor restaurants, flower arrangements and the natural and artificial guidance surfaces planned**. In the test area, a good example of such coordination is the space intended for an outdoor restaurant in Borganäsvägen, Photo 13.

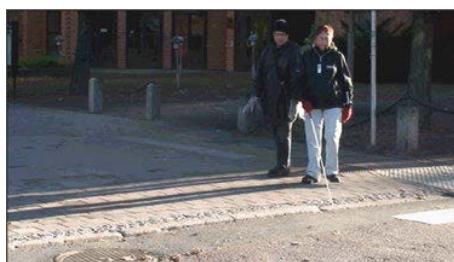
One of the most crucial design details for people with impaired vision when they orient themselves in a walking environment is **clearly marked edges**. When edges are phased off along long stretches, e.g. along entrances, it is often impossible to identify the kerb with the white cane. Some of the participants found it hard to identify the edge at the entrance to the pedestrian section of Borganäsvägen and had to walk across this surface slowly and cautiously, Photo 14.
